Recording Streetscapes

Salim Elwazani and José Luis Lerma

Qayseriyyah Souq, Bahrain

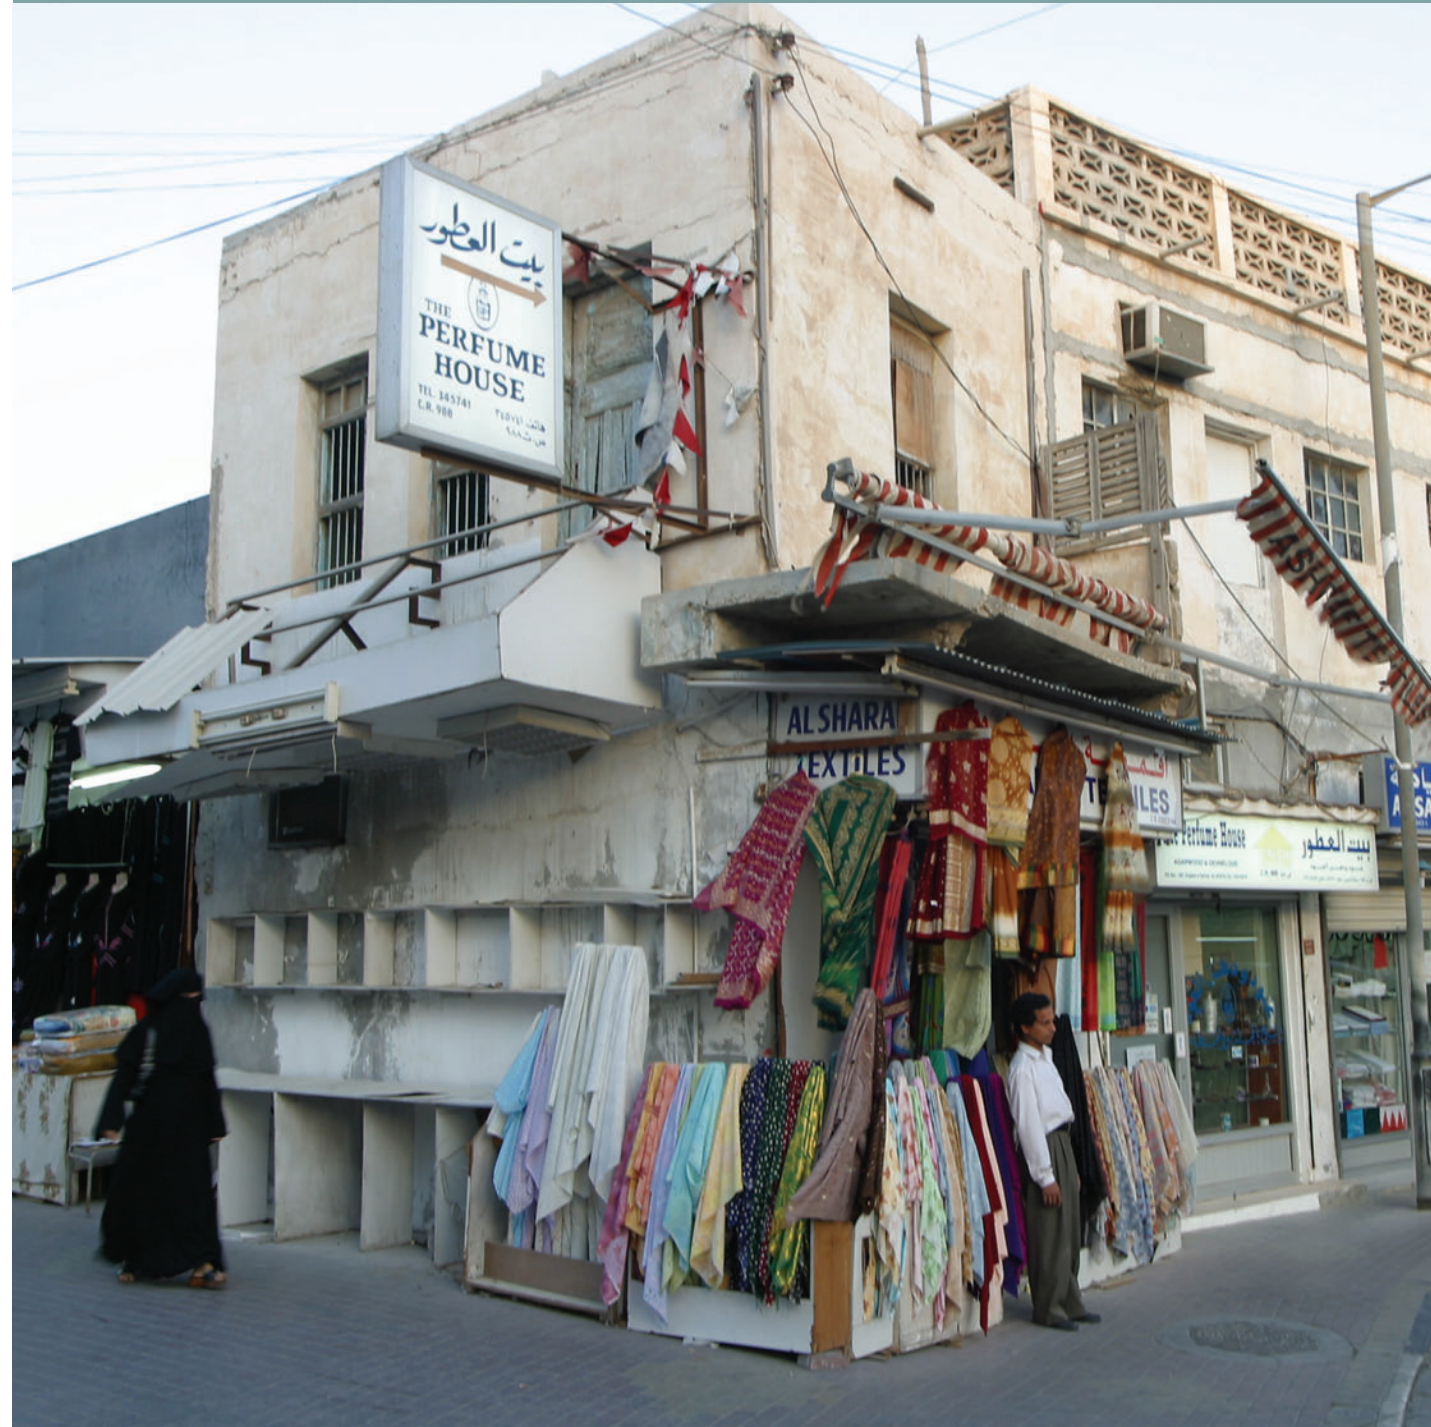
The corner of Sheikh Hamad Avenue and Tujjar Street, Qaysariyyah Souq, in the heart of Muharraq, Bahrain. The souq suffers from exposure to the natural elements, neglect, and inappropriate development. Photo: © Salim Elwazani and José Luis Lerma.

structures and ceilings. The conditions of the structures within the souq vary markedly, but the buildings are generally in disrepair. The souq suffers from exposure to the natural elements and neglect, and from inappropriate development that affects the integrity of the architectural character. Three-fifths of the buildings have retained their original character and are more than fifty years old, with many estimated to be more than one hundred years old. Vestiges of these important older buildings now predominate only in the poorest and most dilapidated sections of the market. The remaining two-fifths of the buildings have been erected within the past fifty years. It is clear that this newer, historically incongruent class of buildings, particu-

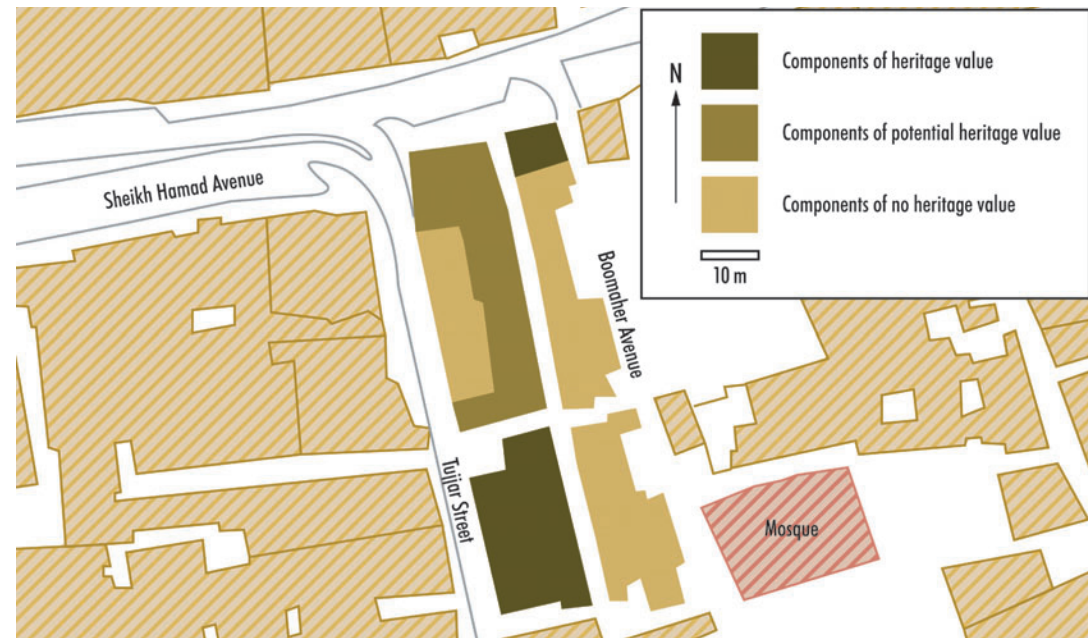
Map of the Qayseriyyah Souq, showing major avenue boundaries, central and auxiliary alleys, and building components of heritage value. Not only are the original visible buildings at risk, but archaeological vestiges are said to be buried within the souq. Map: Steven Rampton.

Roughly rectangular in shape and stretching in a north-south direction, the souq is bounded by paths of contrasting urban character. On the north, the busy, dominant city artery known as Sheikh Hamad Avenue contrasts with a modest pedestrian alley on the south. Traffic-burdened and commercially bustling Tujjar Street, on the west, contrasts with the spacious, lightly trafficked Boomaher Avenue on the east. About 80 meters in length and 30 meters in width, the souq is composed of rather simple one- and two-story structures. The market features a covered central alley running north-south along the ground plan that, with another auxiliary alley, bisects the souq into four parts. This central alley and, to a lesser extent, the auxiliary alley provide access to the inward-facing shops, while the bounding avenues provide access to the outward-facing businesses and upper levels.

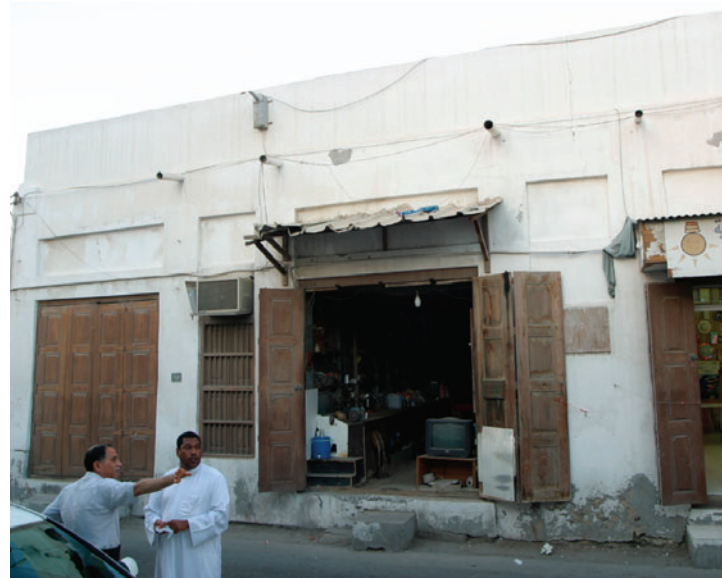
Unrectified photograph of a storefront, taken at an angle. Photo: © Salim Elwazani and José Luis Lerma.

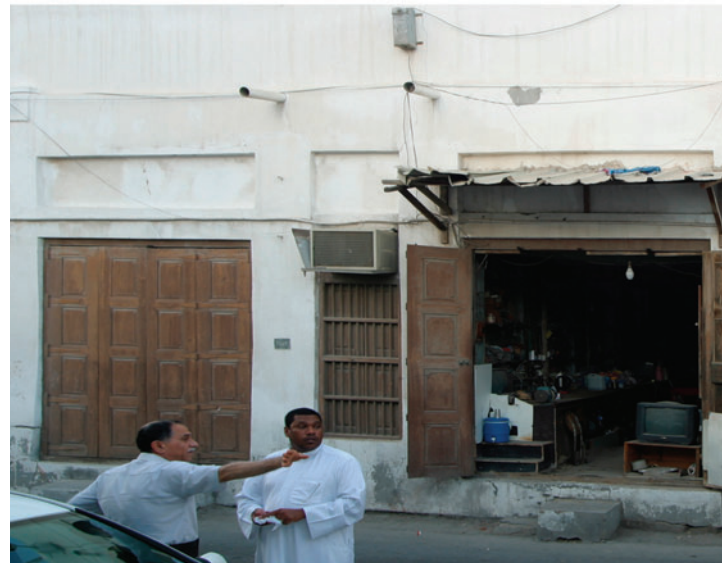
Rectified photograph of the same storefront. Rectification removes perspective, angle, and camera lens distortion to create an image that is on one plane and measurable. Photo: © Salim Elwazani and José Luis Lerma.

perspective, angle, and camera lens distortion, and creates a measurable image that is on the same plane as the building. This method is the most appropriate when the building surface is geometrically flat. Buildings having multiple flat surfaces positioned in different planes can also be rectified: each plane is separately rectified, then brought into one reference plane. Rectified imagery worked particularly well in the souq, as the building facades are relatively flat and images had to be taken at extreme angles with a wide-angle lens in the narrow streets and alleys.

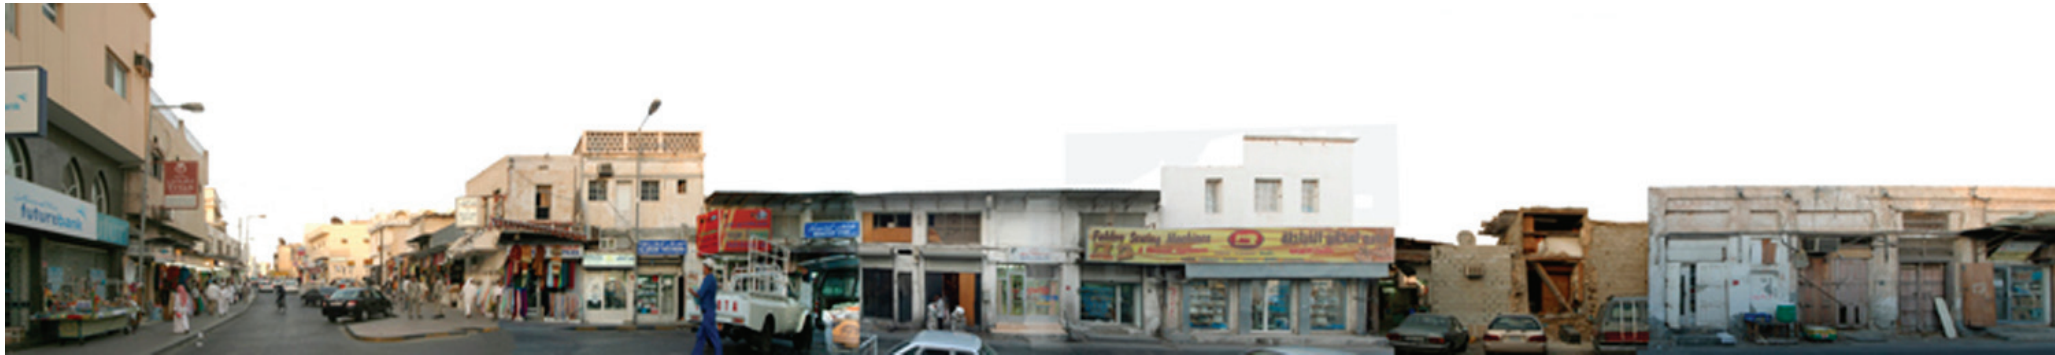
Mosaic of Souq West elevation on Tujjar Street.
Photos: © Salim Elwazani and José Luis Lerma.

was carried out in a repetitive, structured procedure using Adobe Photoshop CS2 (Creative Suite). The procedure began by rectifying a series of adjacent images of each separate building facade, using the souq map and the measurements taken in the field. Using the overlap between images, individual rectified images were then fused into a combined image called a mosaic. This process produced a new, expanded mosaic of the entire streetscape. Color processing was necessary in order to maintain some homogeneity throughout the composition. Panorama Tools, a free plug-in added to Adobe Photoshop CS2, was also used to correct lens distortion. Adobe Photoshop CS2 software has a special filter called Lens Correction that performs the same correction function.

The team strove to establish a rate of progress that would help the project manager realistically estimate the amount of work that could be accomplished in a given time. The documentation process resulted in more than two hundred images, of which twenty-six were rectified and combined to produce mosaic streetscapes of the souq. It also resulted in some general context images, but more important, it yielded more than one hundred fifty images that could be rectified in the future, an important consideration given the limited time available for the preliminary study. The pace of the work was rapid, as it was unclear from the outset how fast the photography and rectification would proceed.

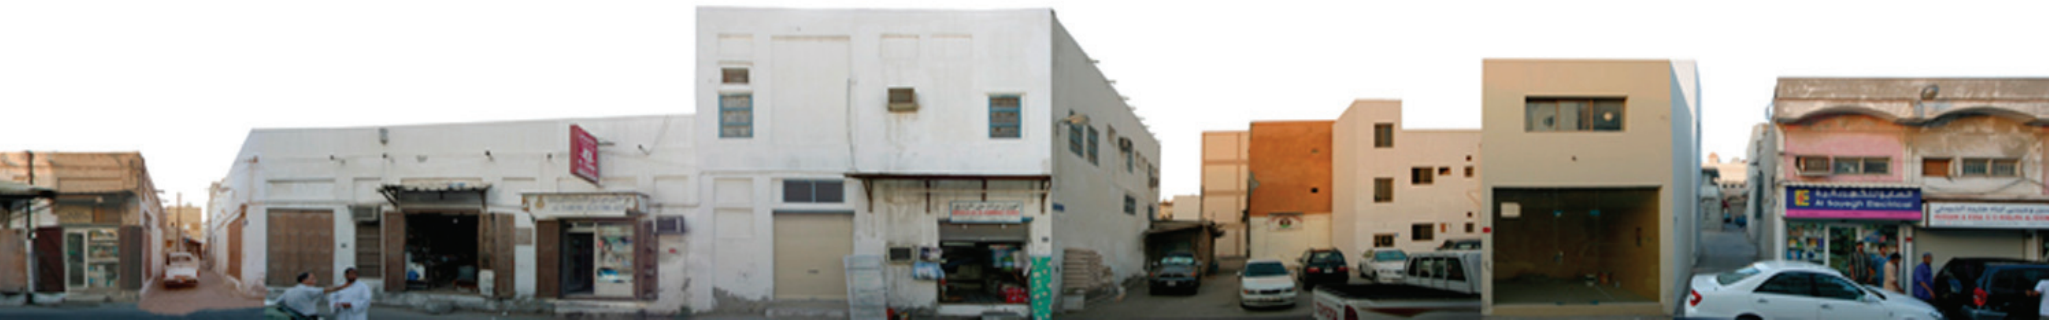
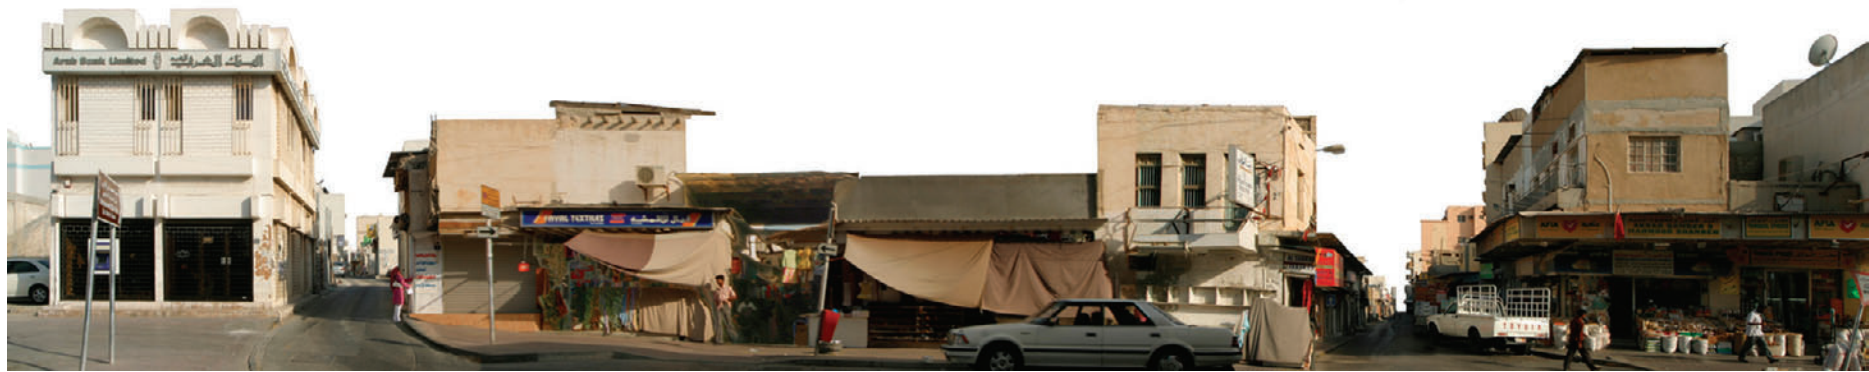
Mosaic of Souq North elevation on Sheikh Hamad Avenue.
Photos: © Salim Elwazani and José Luis Lerma.
